# The Flood Company Window Barrier Testing

HR Wallingford report on a The Flood  
Company Ltd flood barrier - non Kitemark

CAM7525-RT001-R01-00

August 2015

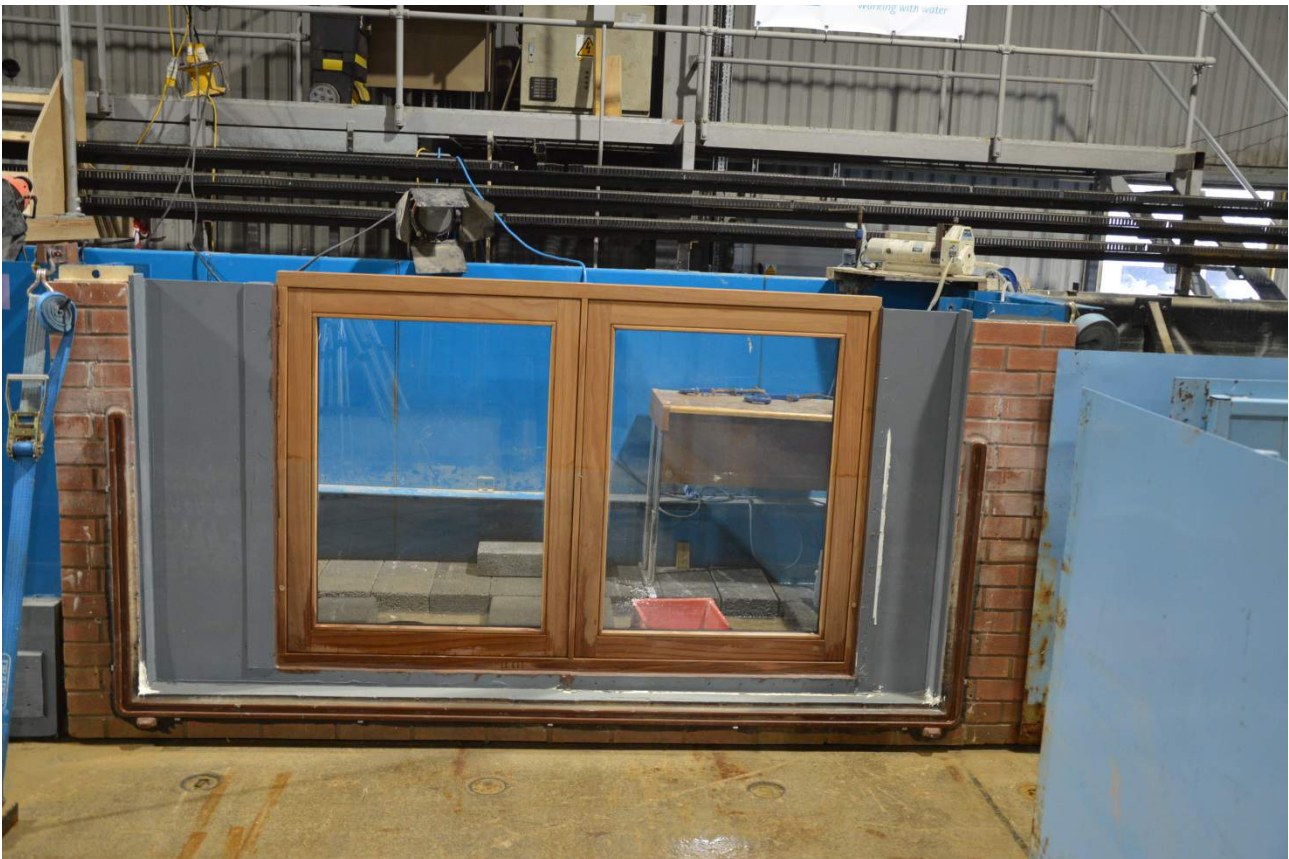
Figure 1.1: The Flood Company flood windows in the HR Wallingford test rig

The products were a pair of windows, provided and fitted by the company and consisted of one outward opening window and a fixed closed window. Both were mounted together in a 1800mm x1200mm x90mm frame (Figure 1.1).

*The opening window can here be seen on the left, and the non-opening on the right.*

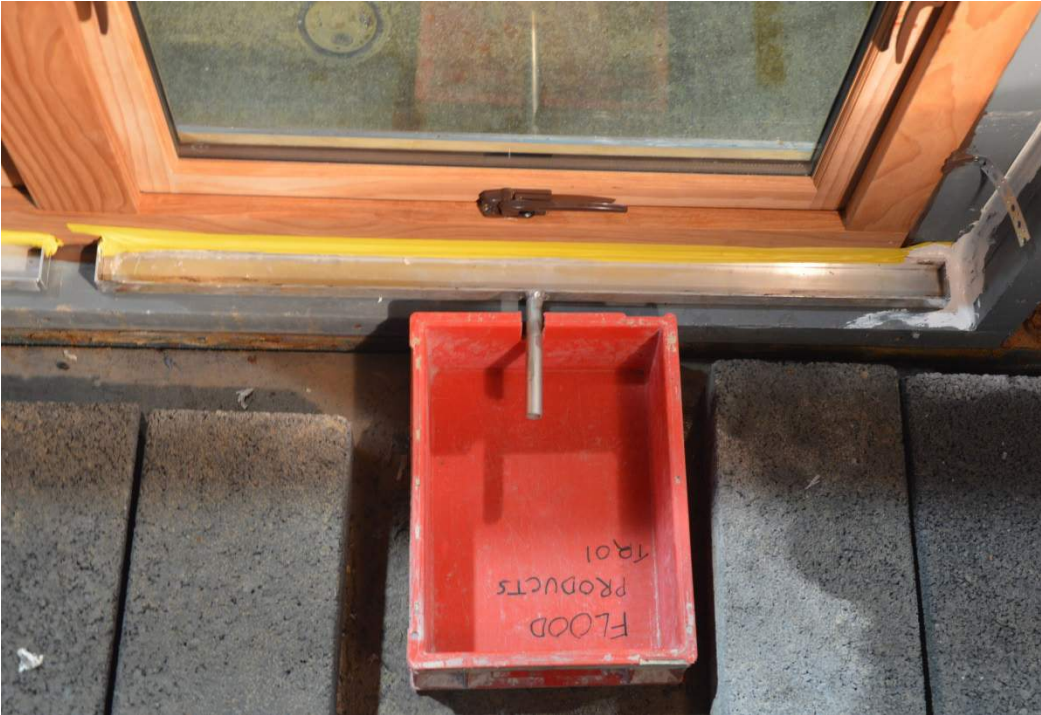
Figure 1.2: View from inside test rig showing drip tray and collection tank under the opening window.

A small aluminium drip tray was placed behind the products to capture any leaking water. This set up is shown in Figure 1.2 and Figure 1.3 for the opening and non-opening window respectively.
